# Damage Detection Based on Object-based Segmentation and Classification from High-resolution Satellite Images for the 2003 Boumerdes, Algeria Earthquake

**Abstract:** A strong earthquake of magnitude 6.8 struck the Mediterranean coast of Algeria on 21 May 2003 and the city of Zemmouri in Boumerdes province was most heavily damaged. QuickBird satellite observed the Zemmouri area on 23 May 2003. By image sharpening, buildings, cars and even debris can clearly be identified in a natural colour image. Preliminarily, the present authors performed visual damage inspection comparing the post-event image with an image acquired before the earthquake. As a result, totally collapsed buildings, partially collapsed buildings, and buildings surrounded by debris were visually identified. Additionally, debris surrounding damaged buildings was also extracted. Although these observations indicate that high-resolution satellite images would be able to provide quite useful information to emergency management after natural disasters, it can also be said that the visual damage interpretation is time-consuming. For practical purposes, it must be necessary to complete damage detection as quick as possib

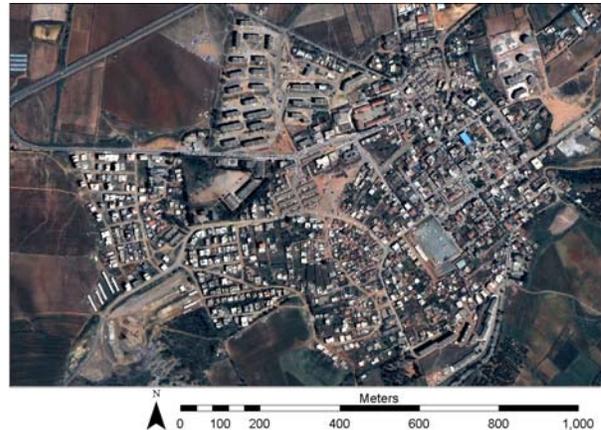
Figure 2. Pan-sharpened natural color QuickBird image of Zemmouri City acquired on 23 May 2003.

Then, pan-sharpened images were produced through combining panchromatic images of 0.6 m resolution and multi-spectral images of 2.4 m resolution, as shown in Fig. 2. By this image enhancement, buildings, cars and debris can clearly be identified. A pre-event image and a post-event pan-sharpened image were produced and they were used in visual damage inspection. As well as that, the post-event image was used in automated damage detection.

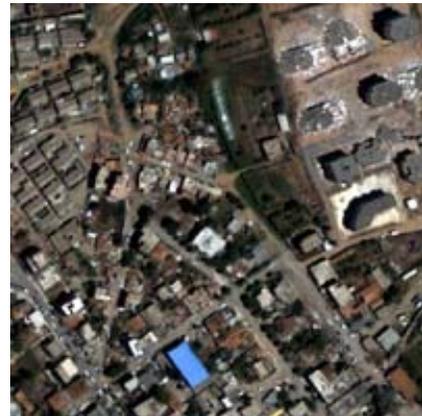
Figure 4. Image of the study area.

There were three steps in this study. Firstly, 1) visual detection of debris from pre- and post-event images was performed, preliminarily. Secondly, damage areas were automatically extracted using both 2) a pixel-based method and 3) an object-based method. Finally, based on the visual detection result, the accuracies of the two automated detection methodologies were evaluated, which is mentioned in the next section. The flowchart of all operations beginning with the acquisition of images is shown in Fig. 3, and the study area in this paper is shown in Fig.4.
