IMAGE CHANGE DETECTION ON URBAN AREA: THE EARTHQUAKE CASE

G. Bitelli ^a, R. Camassi ^b, L. Gusella ^{a*}, A. Mognol ^a

KEY WORDS: Remote Sensing, Earthquakes, Change Detection, Disaster, Multitemporal

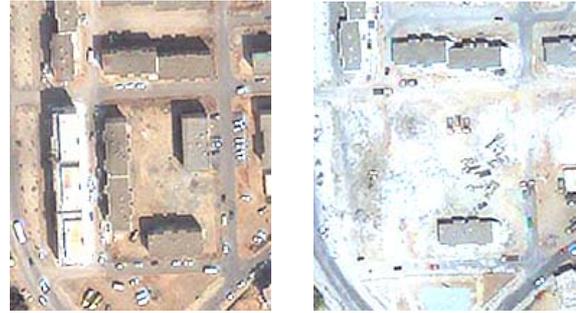
Figure 1. Boumerdes, change between 2002, April 22 and 2003, June 18.

Using Quickbird pre- and post-event images is possible to produce a map of damaged buildings, as required by EMS 98 macroseismic classification, at least for higher grade of damage. However, two Quickbird images need correction and registration to have a correspondence between single structural units on two different images (Fig. 1).

For the Boumerdes earthquake, the pre-event Quickbird image was subjected to a multiresolution segmentation by eCognition software in order to obtain meaningful region/objects, representing buildings. eCognition uses some keywords to define how the segmentation is done: scale, color and smoothness. Scale is the magnitude of the object, and is different from resolution, which is the minimum feature detectable on the image. Using the concept of scale is possible to detect features with different magnitude, for example large built areas or forest (high scale value) and single buildings or trees (small scale value). The scale is defined as the value of an heterogeneity factor beyond which two objects are fused together. This heterogeneity factor is a weighted mean, from 0 to 1, of a spectral heterogeneity (color) and a shape factor; the latter is composed by smoothness and a compactness factor. A low color factor (thus a high shape factor) is used because buildings present some irregularities on the roof (principally dormers or saturated areas).

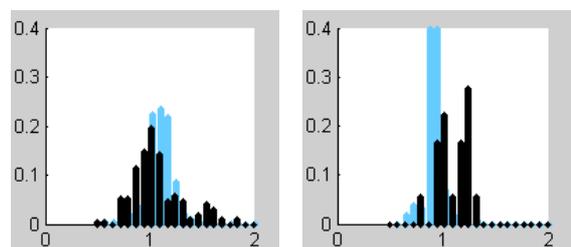
Figure 2. Left: ratio (post/pre event) in damaged buildings (black) and no damaged buildings (blue); Right: reflectance increasing in building and surroundings.

As can be observed in Figure 2 (left), it is quite impossible to define a threshold value to classify the damage using only roof reflectance. On the other hand, photo interpreters take into account surroundings of object/buildings to establish if a building is damaged or not: to simulate the surrounding of every building, a segmentation with an higher scale can be

performed, showing a significant increasing in reflectance on the damaged structures (Figure 2, right).

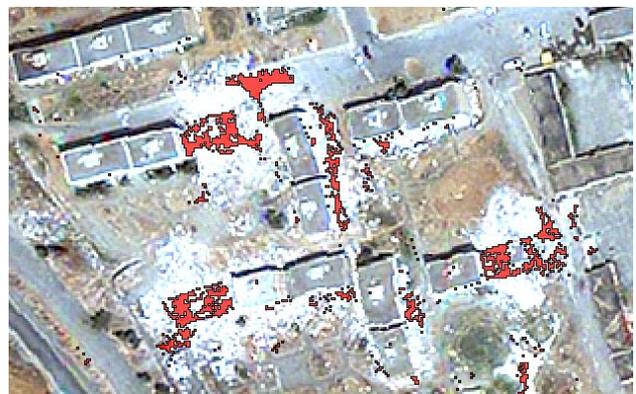
Figure 3. Boumerdes, change detection results by pixel-based classification.

The change detection module was applied between pre- and post-event QuickBird images. In order to remove false changes caused by presence of shadows, ISODATA classification of pre-event image was used: a class for shadows was identified and removed by its implementation in the decision tree. Other two variables were used in order to select the urban area: ISODATA classification of pre-event image and NDVI of pre- and post-event images.
